DARWIN D. MARTIN HOUSE

CULTURAL LANDSCAPE REPORT

Prepared for the Martin House Restoration Corporation
Buffalo, New York

Prepared by Bayer Landscape Architecture, PLLC
Honeoye Falls, New York

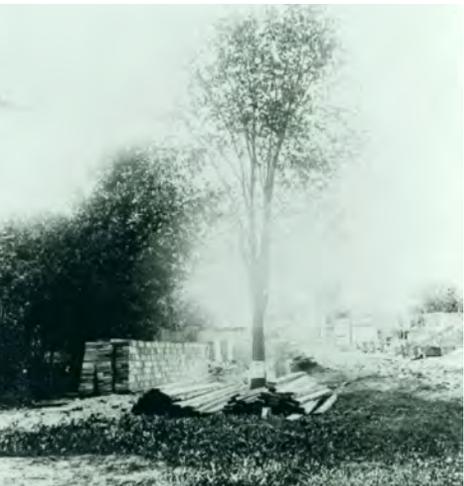
American elm planted near west lot line, c. Aug 1904.

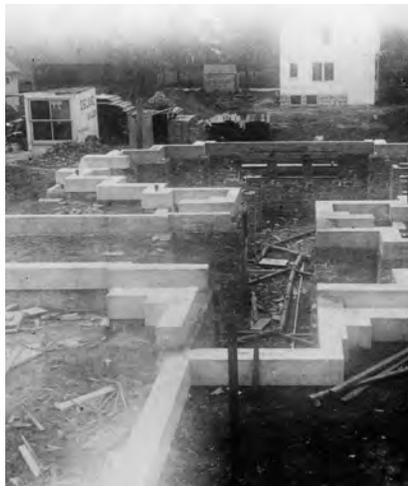
*Fig. 20, bottom right*

Foundation for garage and conservatory, c. July 1904.

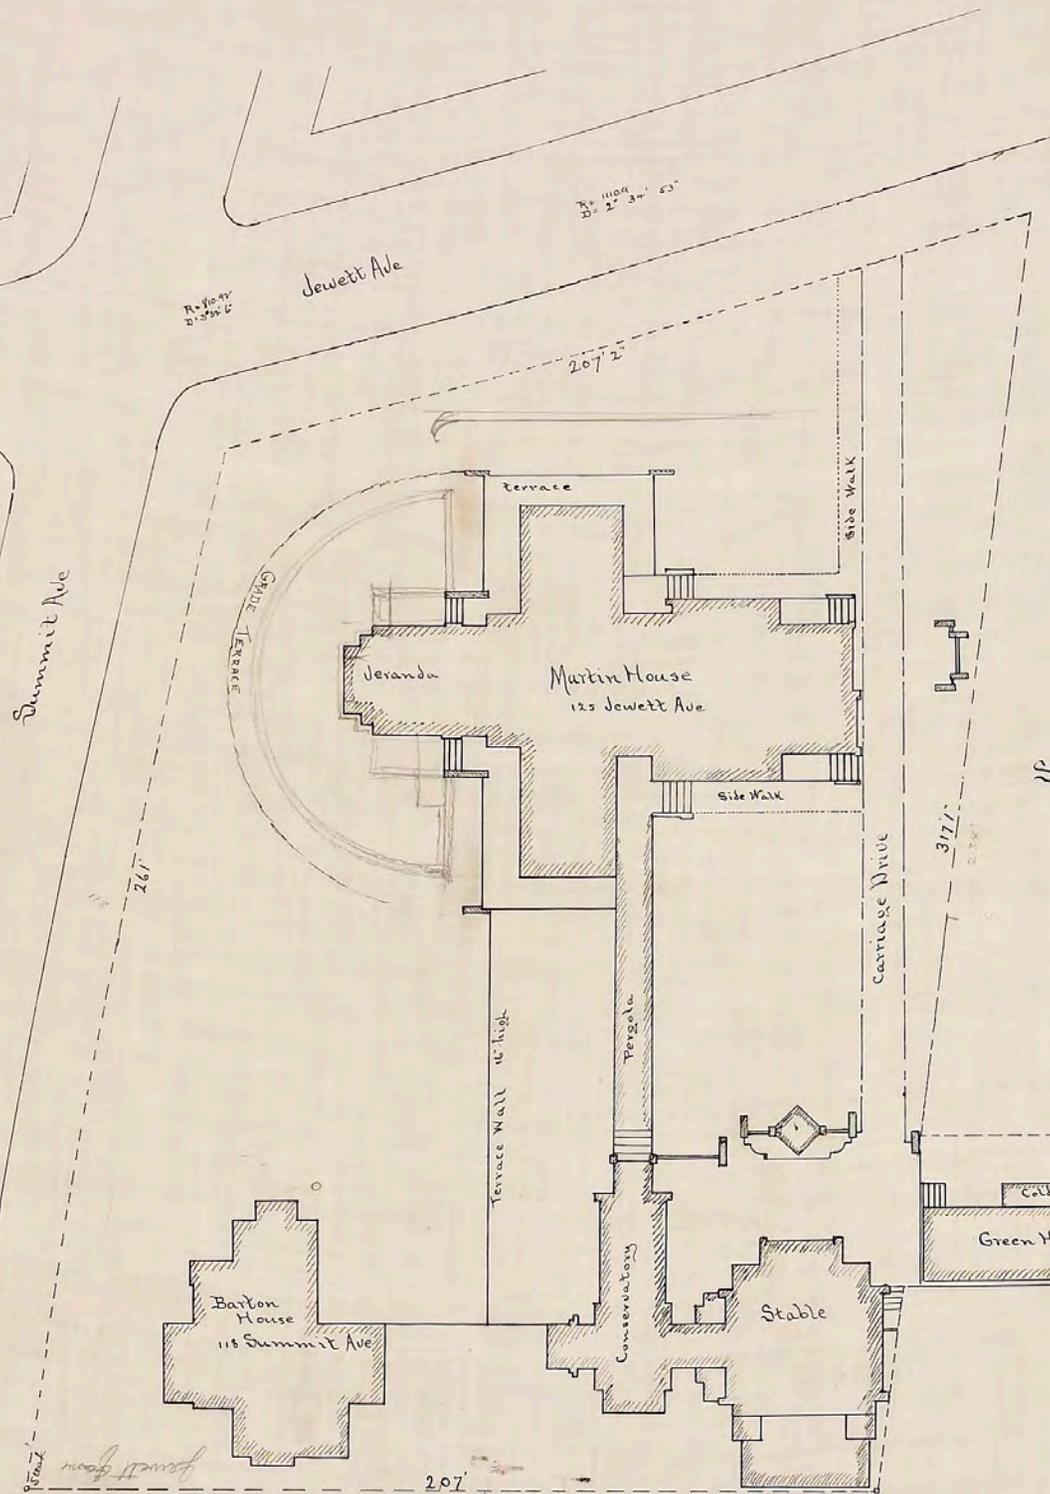
Map
 Showing plot at Northwest corner
 of Jewett and Summit Ave
 for
 Darwin B. Martin
 Scale 20 ft = 1 inch

O. S. Lang
 4/19/00

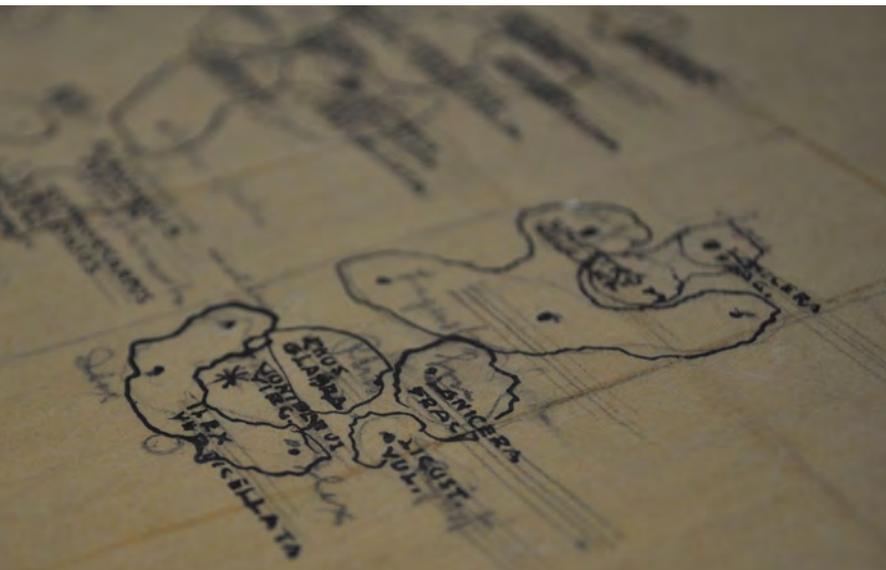
Detail of Barton House area, original ink on linen Plan of Plantings, 15 Feb 1905.

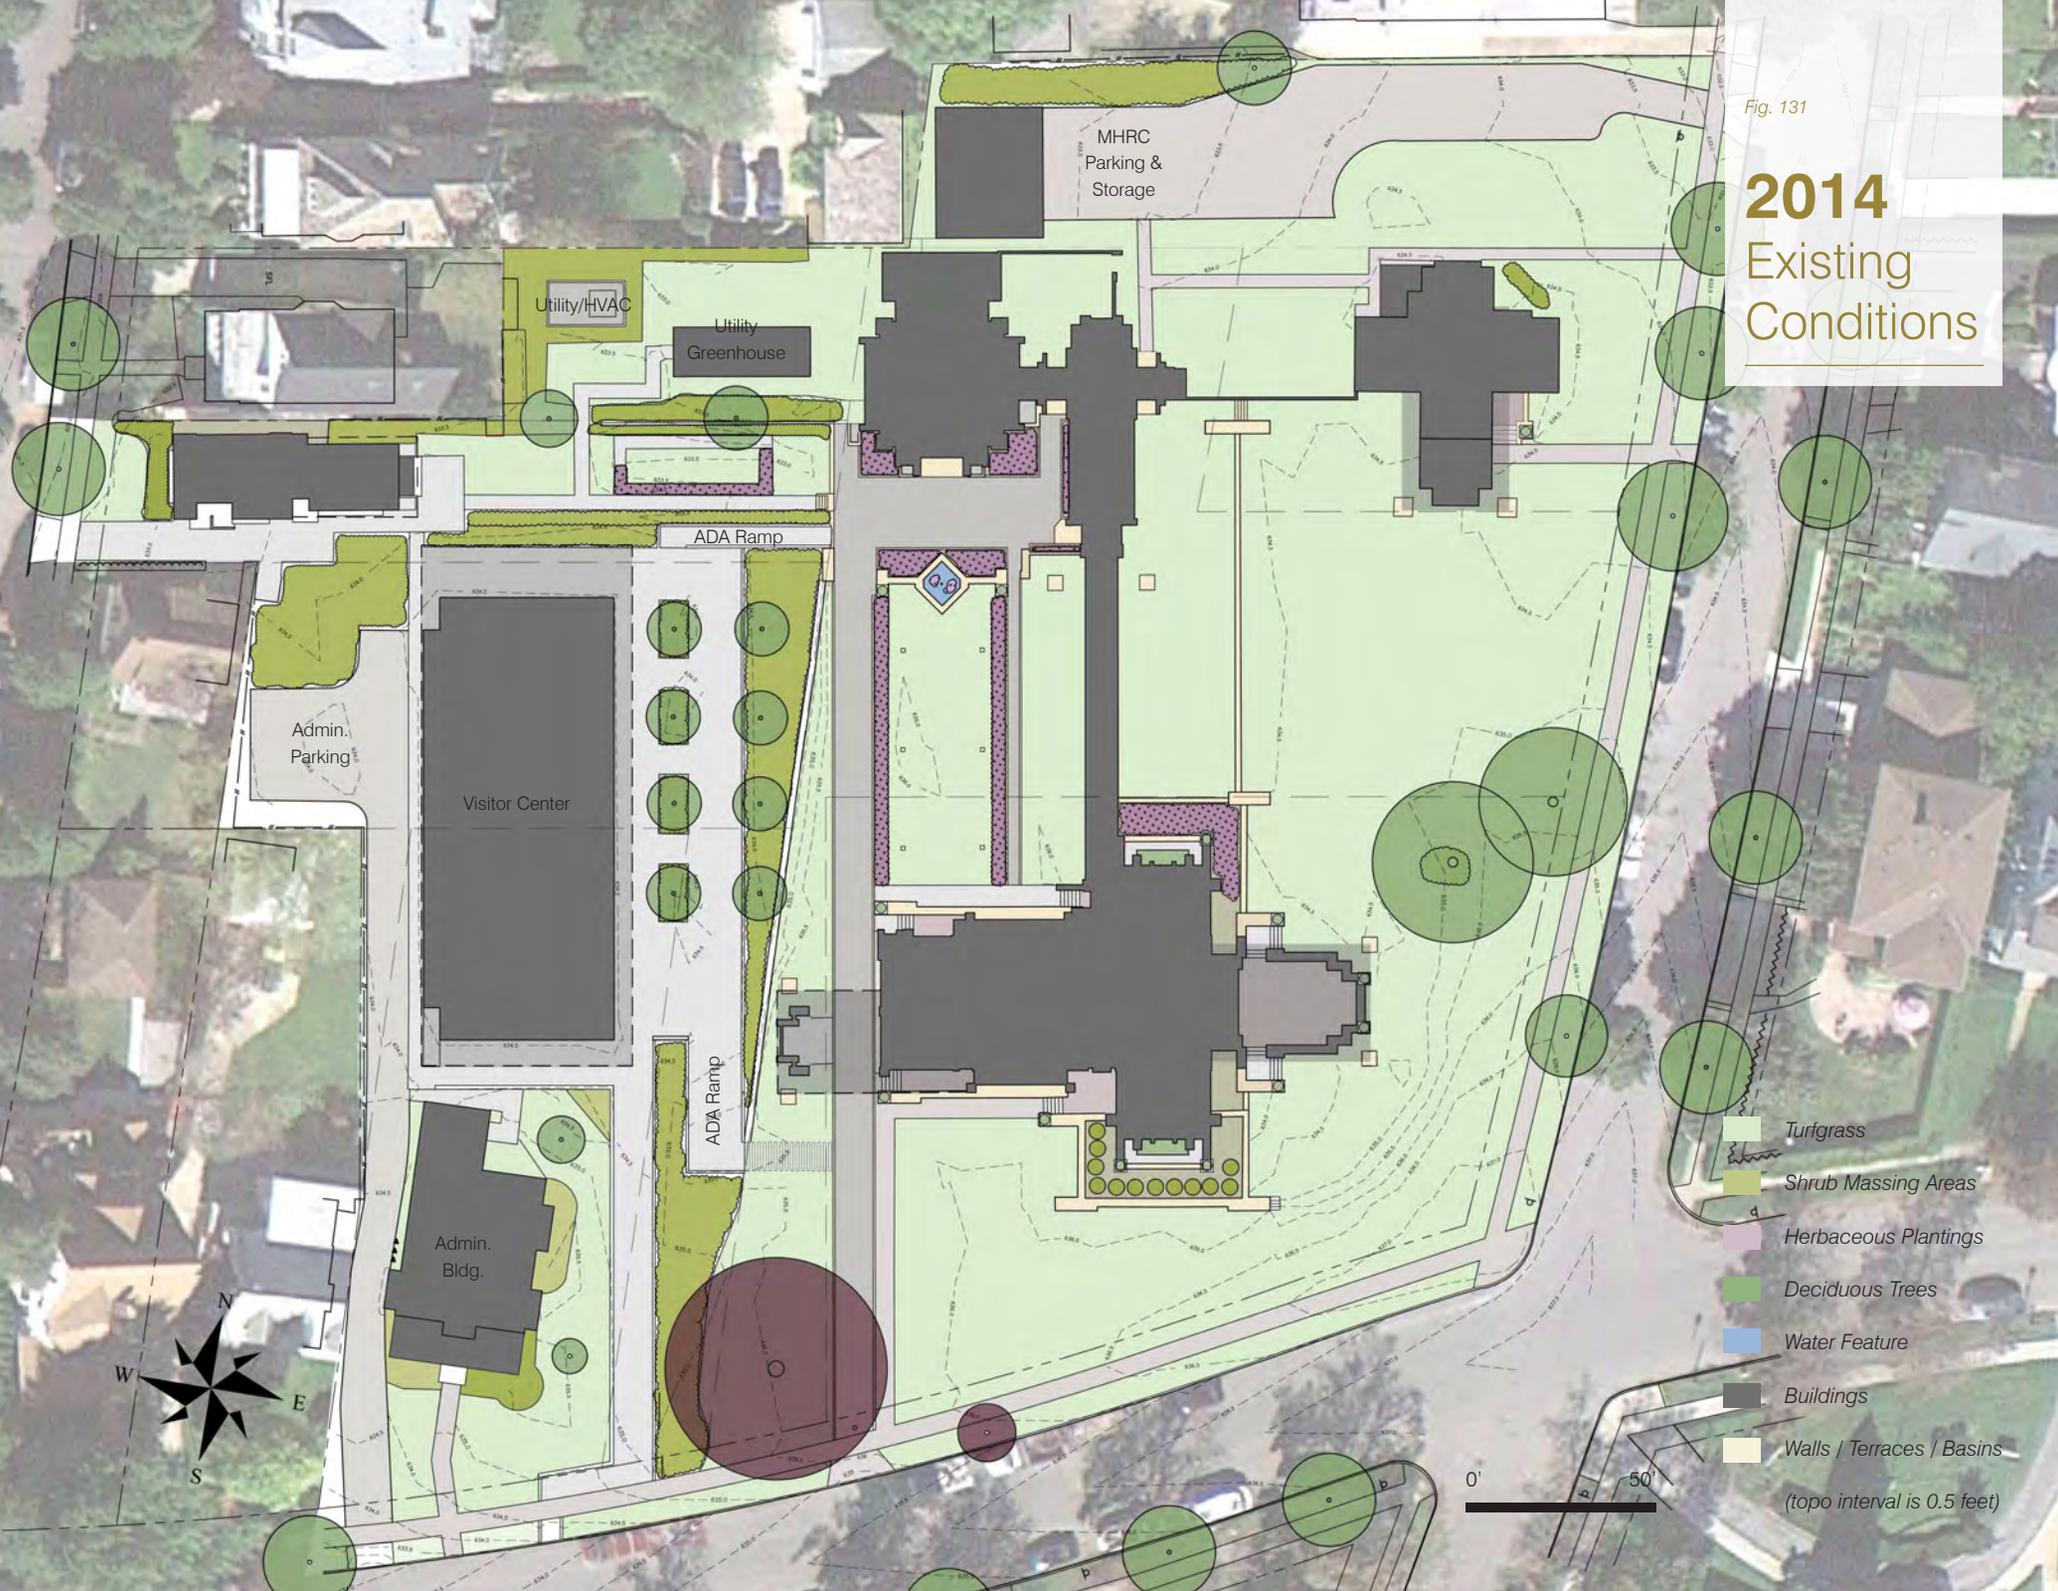
Fig. 132, top

2014 Existing Conditions

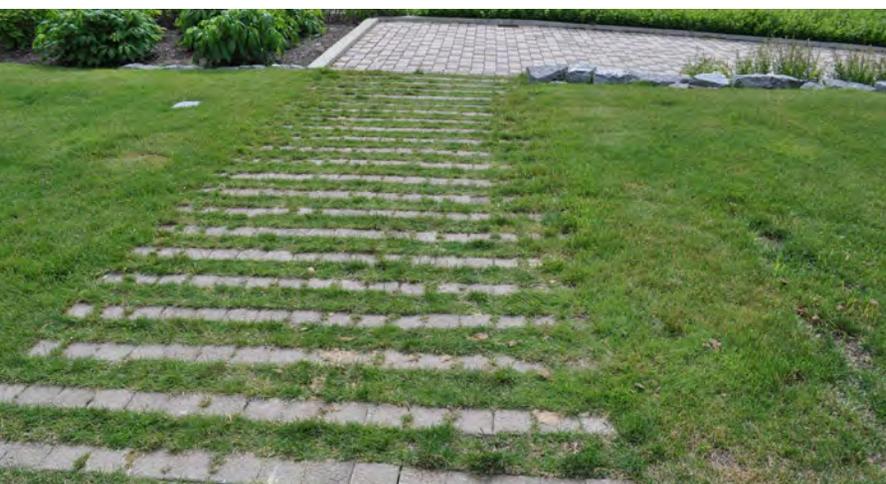
Concrete unit-paver pathway linking driveway to Visitor Center area.

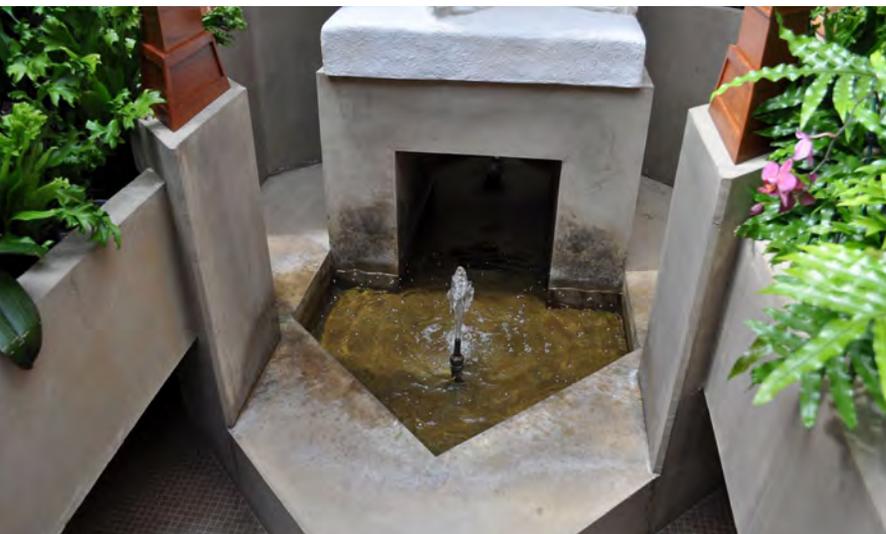
Fountain at base of Nike sculpture, in conservatory.

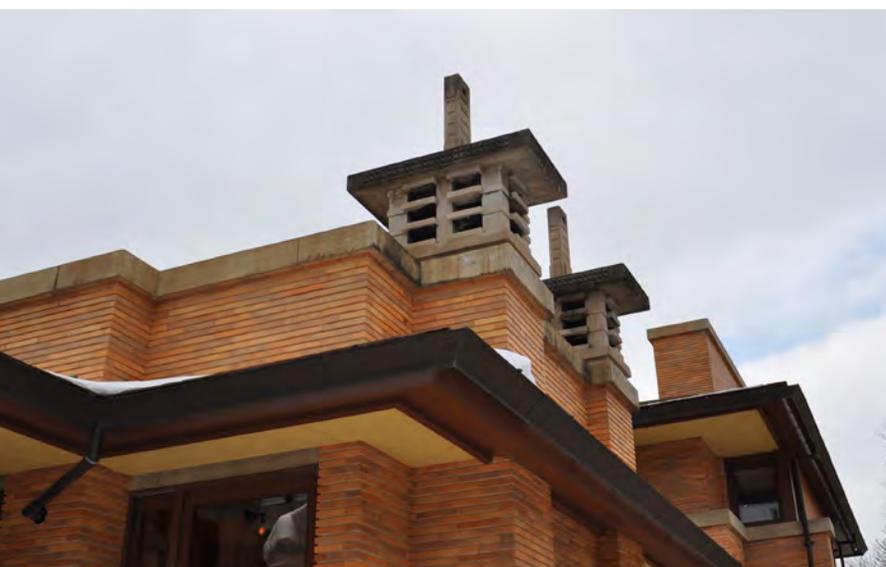
Concrete 'birdhouses,' four sit on top of the conservatory.

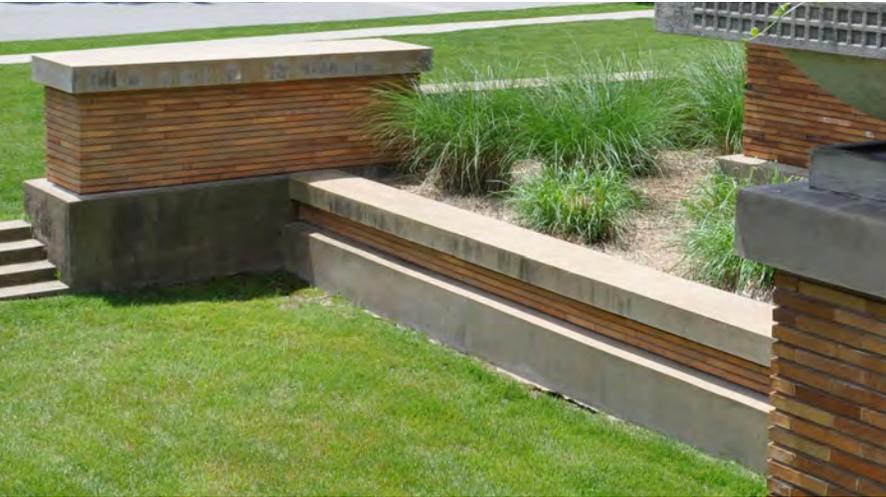
Fig. 165, top

Front raised planter, foundation void visible, potential undesirable water penetration.

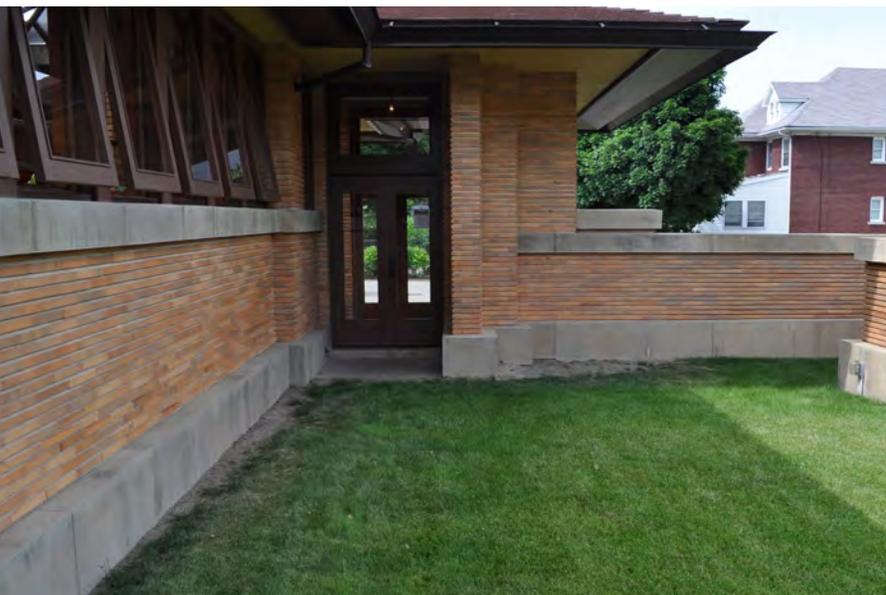
Fig. 166, bottom

Turf wear near conservatory, east facade.

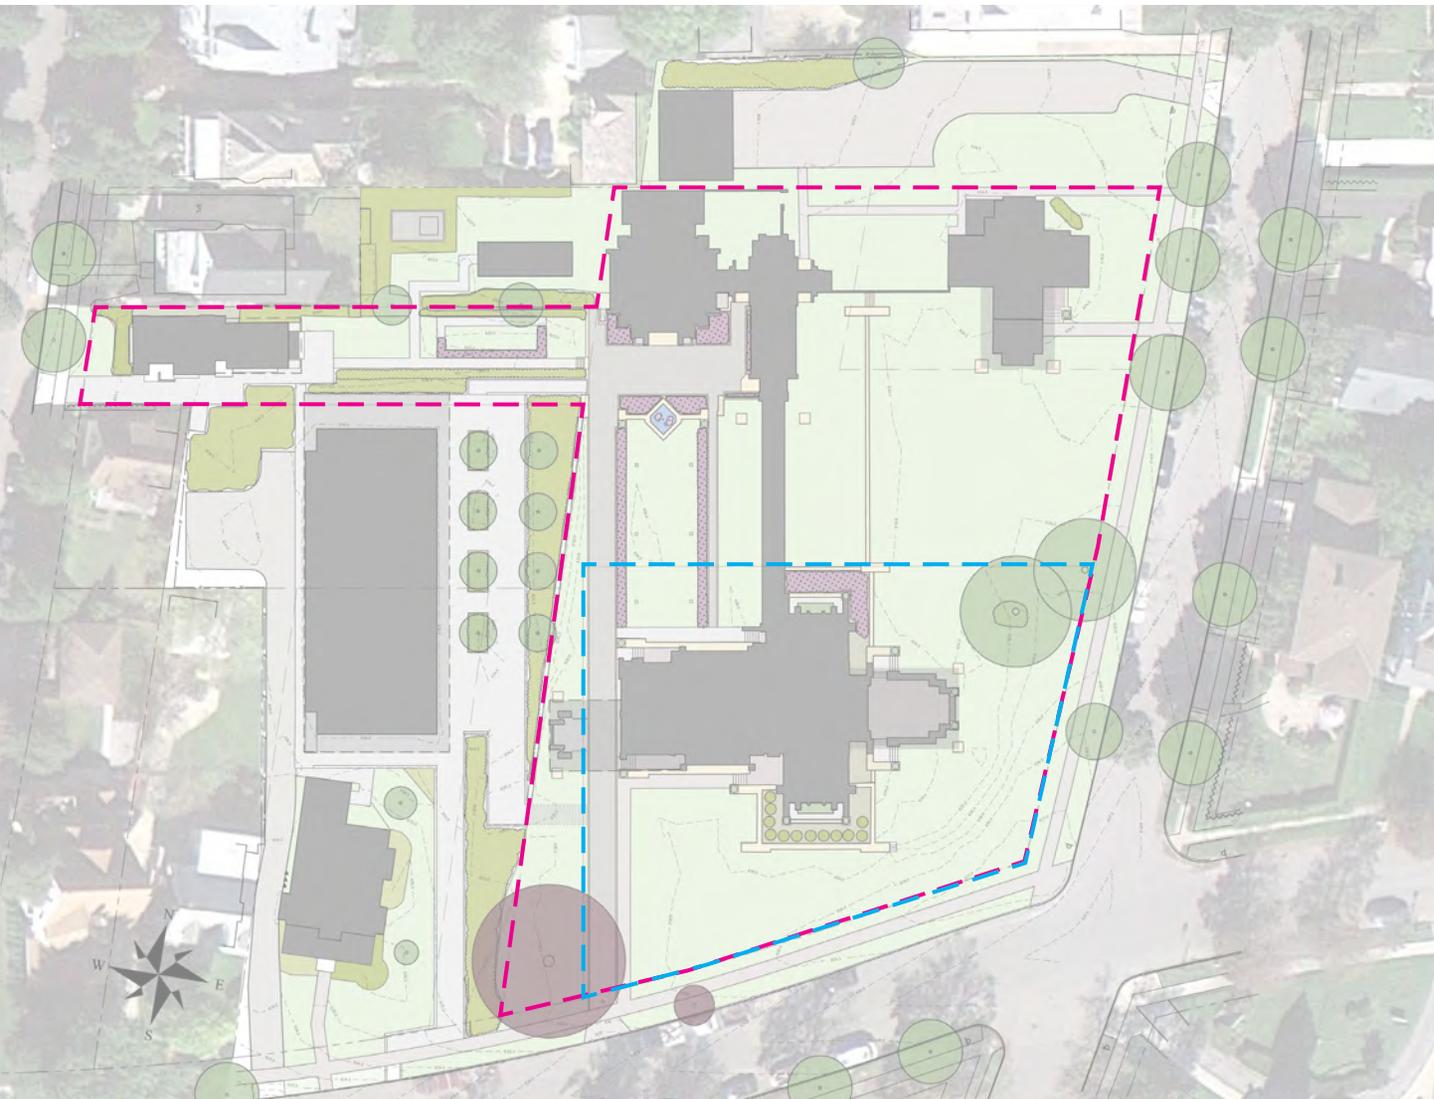
- - - National Register boundary (1975)
- - - National Historic Landmark boundary(1986)

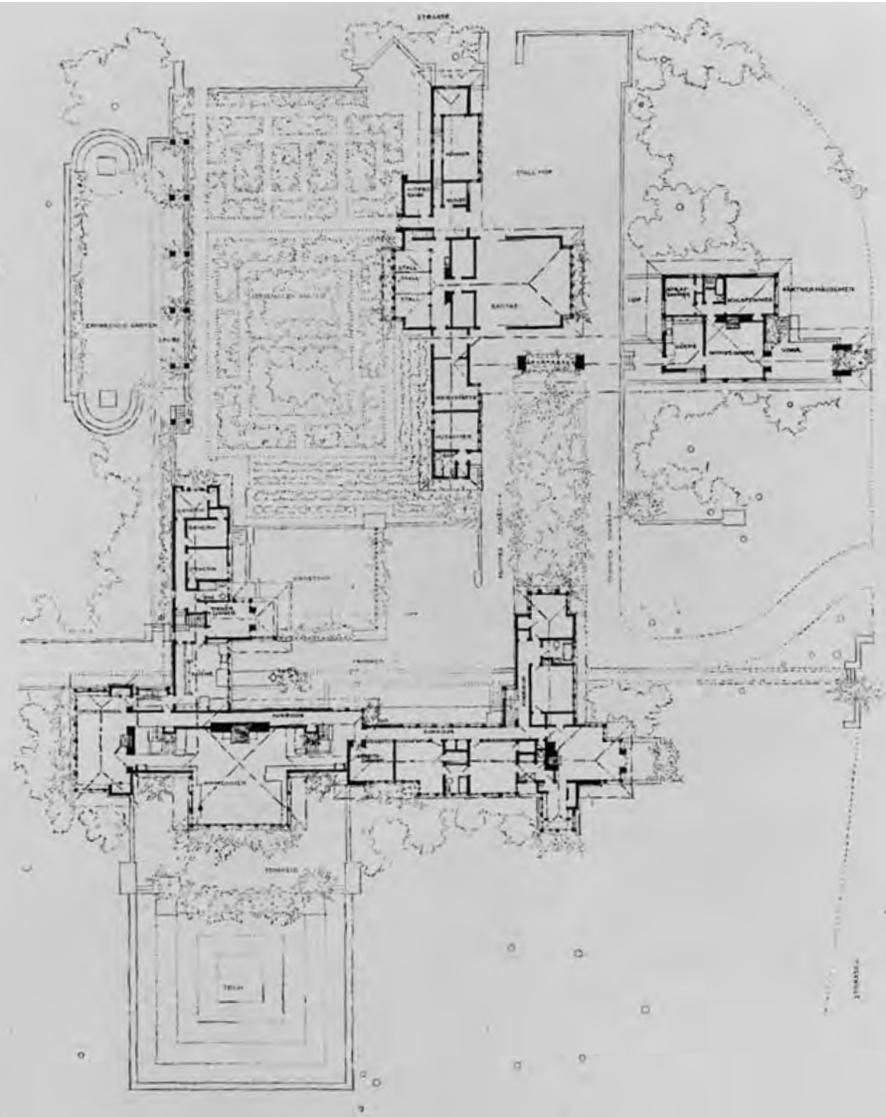
Avery Coonley House, site plan, Frank Lloyd Wright, 1908, unrealized (landscape).

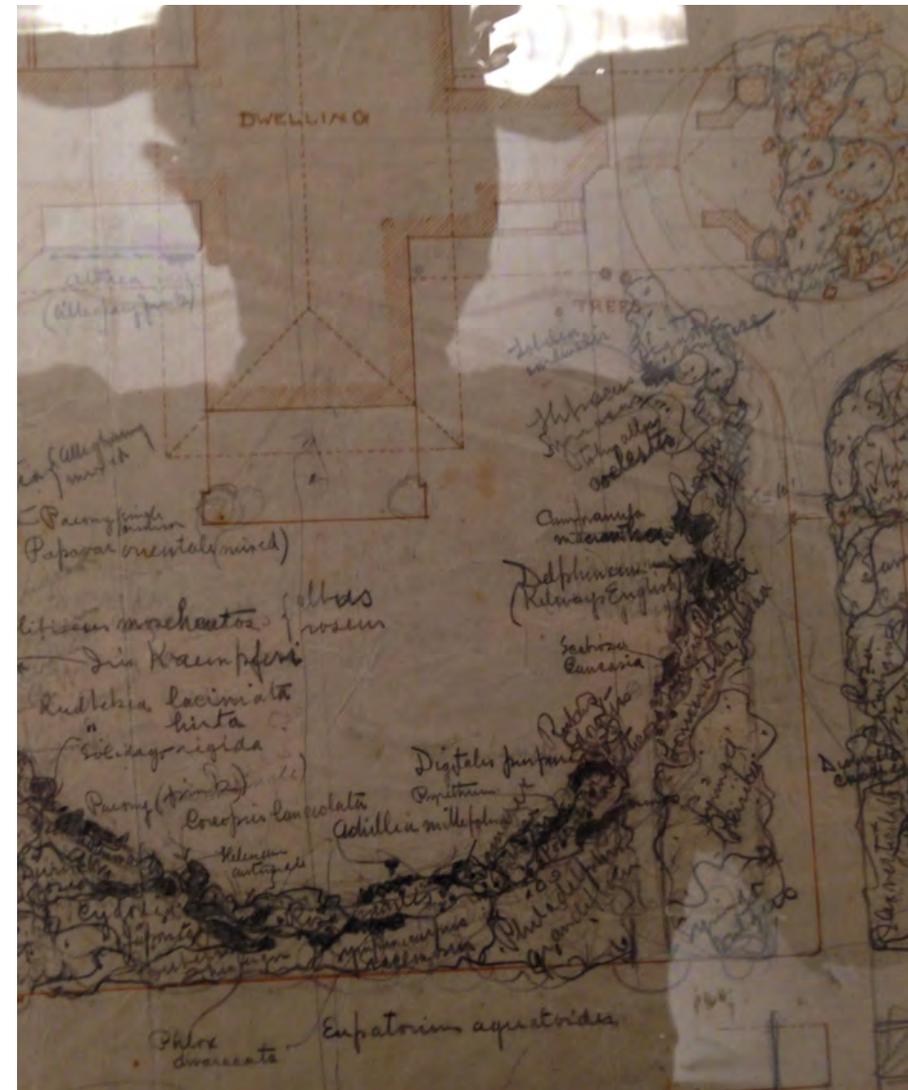
Willits House (1902), 'hemi-cycle' style plantings sketch, excerpt, Griffin / Wright.

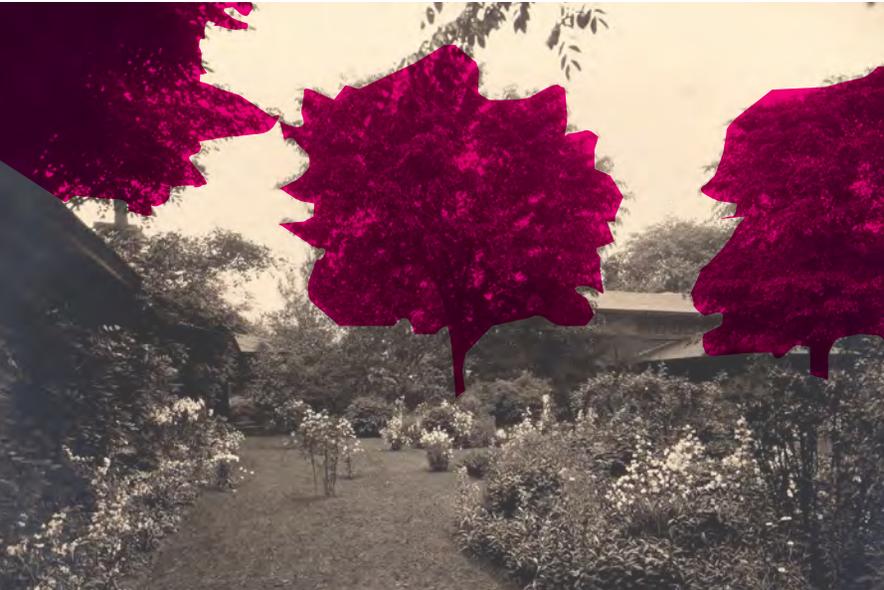
Annotated photograph (1923) of the Summit Terrace (looking north from Summit Terrace toward Barton wall), showing significance and visual prominence of on-site tree canopy within the landscape.

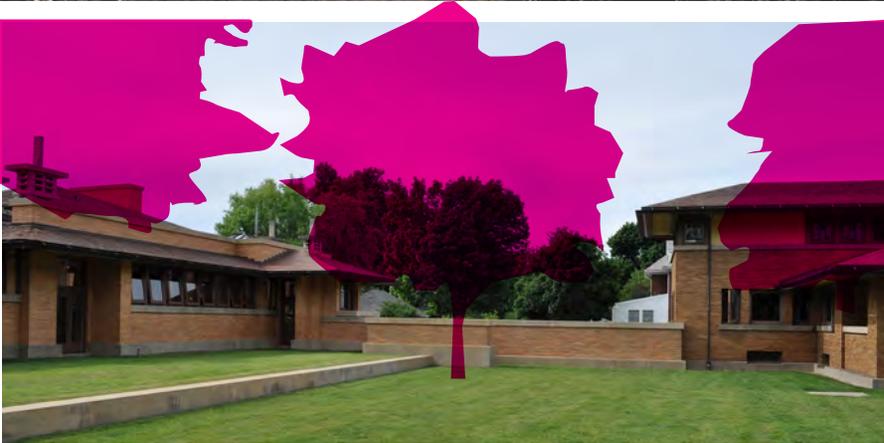
Fig. 200, bottom

Contemporary photograph showing potential visual influence of missing tree canopy on existing site. Note, the point of view has shifted to the Summit Lawn.
